Project No: TTL10/0017
Report No: RGHB10/0001-4
Date of Report: 6 September 2010
Thermal Test Laboratory cc
Building 28, CSIR, Pretoria
Tel: +27 (12) 349 1023

THERMAL RESISTANCE TEST REPORT

CLAY BRICK ASSOCIATION of SA (CBA)

Determination of the Thermal Resistance of Thermally Insulated Building Envelope Systems using CBA Bricks in accordance with ASTM C 1363-05: *Standard Test Method for Thermal Performance of Building Materials and Envelope Assemblies by Means of a Hot Box Apparatus*.

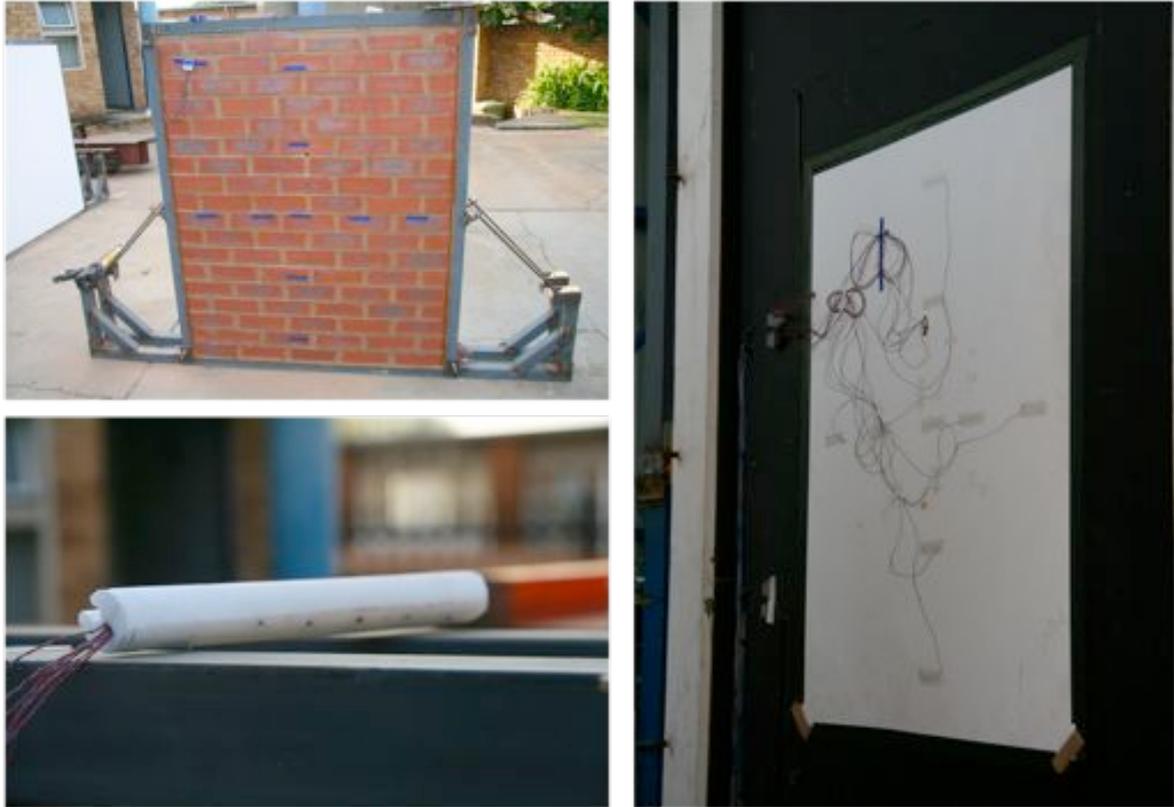
FIGURE 4: A typical specimen instrumented on the climate side in the steel construction jig before testing (top left), the XPS instrumentation probe used for measuring temperatures at various depths to establish thermal stability (bottom left), and a view of the climate side of an instrumented specimen mounted in the RGHB prior to testing (right).

Since the thermal resistance of the clay brick walls to be tested can only be determined in a system test, four test specimens of nominally 1.5 m (h) x 1.2 m (w) were constructed. The specimens were constructed in Supawood frames mounted inside adjustable steel frames (see Appendix A) to ensure that the dimensions of the specimens are within the 1 mm tolerance allowance. The specimens were allowed to dry for a period of 28 days.

selected positions on both surfaces of the specimens. An extruded polystyrene (XPS) probe, instrumented with 6 equi-spaced type T thermocouples mounted along its length, is then mounted near the centre of the test specimen. It is used for measuring the dynamic specimen core temperatures of the specimen to determine whether stable conditions have been reached.

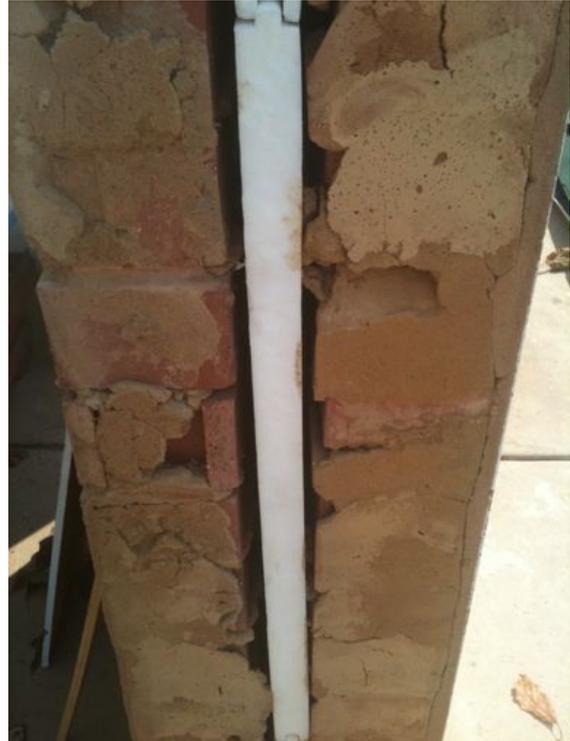
ANNEXURE B: SPECIMEN CAVITY DIMENSION

Wall system 3 was inspected after testing and its critical dimensions were checked. It was noted that the width of the cavity is equal to 18 mm on average. The cavity was partially filled with mortar spillage from the side of the external skin.

The measured thermal resistance for the third and fourth wall systems tested (Wall 3 and Wall 4) differ notably from wall systems one and two, but also from one another ($R_{th,3} = 1.14$ and $R_{th,4} = 1.43$). The physical differences between these two wall systems are in the bricks used for the external wall (perforated face bricks for wall system 3 versus plastered stock clay bricks for wall system 4), and the type of insulation material panels between the bricks. Wall system one contains a 30 mm Isoboard insulation panel, while wall system 4 contains an expanded polystyrene insulation panel. Both wall systems were specified to have the same 20 mm air gap (see Appendix B). The measured difference in the thermal resistance between these two specimens is more than what is expected from the above-mentioned differences.

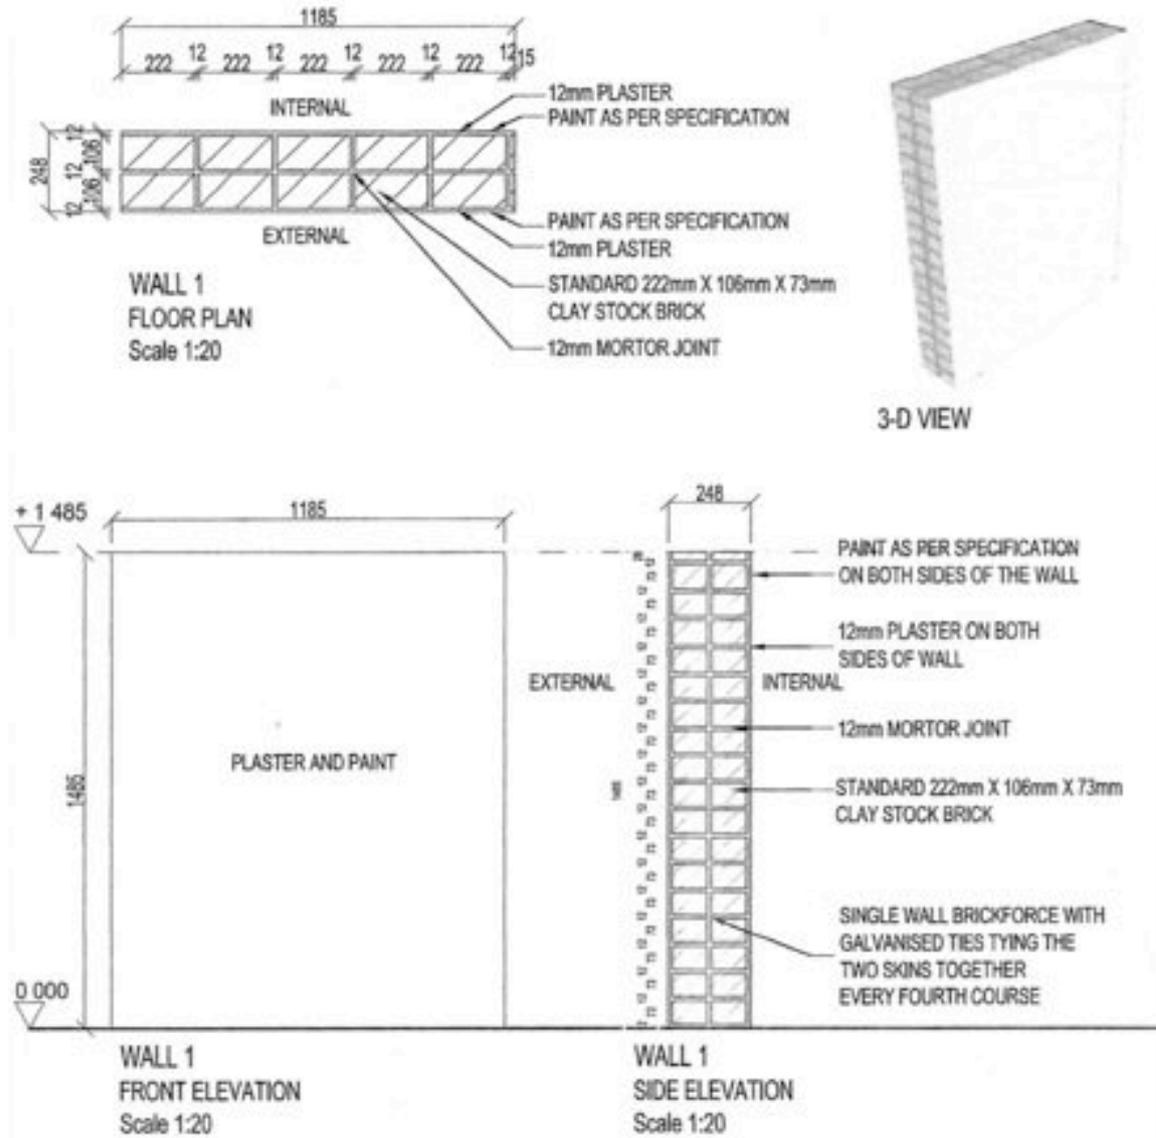
WALL 1

Measured thermal resistance for Wall 1 = $0.35 \text{ m}^2 \cdot \text{W/K}$

- **WALL 1:** A double clay stock brick wall with 12 mm mortar joints and with 12 mm plaster on both sides (painted white), with single wall brickforce with galvanised ties tying the skins together every fourth course.

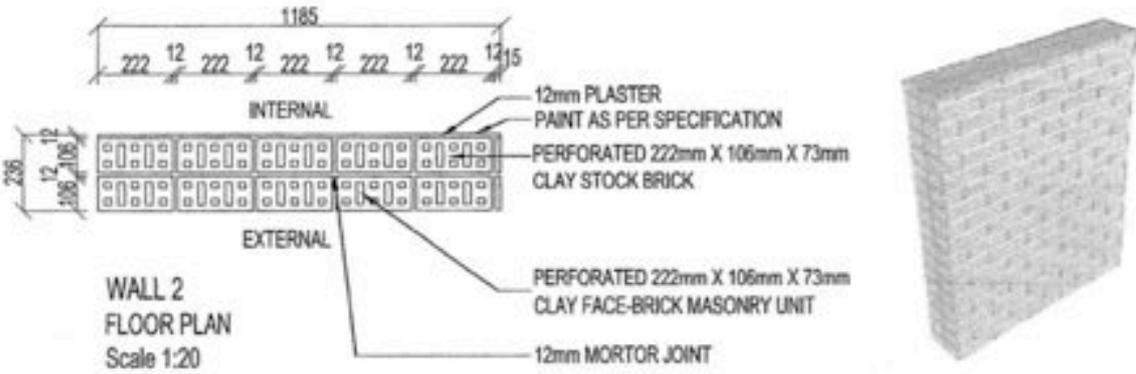
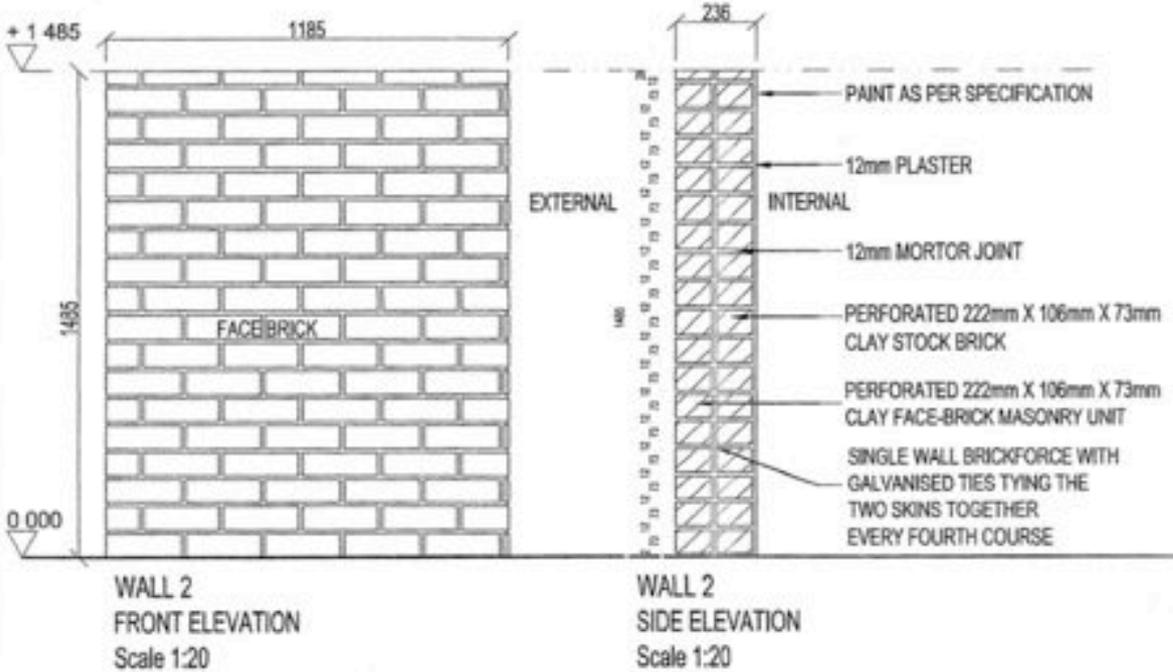
WALL 2

Measured thermal resistance for Wall 2 = 0.37 m²·W/K

- **WALL 2:** A double brick wall made from perforated clay stock brick on the room side and perforated face brick masonry units on the climate side with 12 mm mortar joints and with 12 mm plaster on only the room side, painted white. The specimen has single wall brickforce with galvanised ties tying the skins together every fourth course.

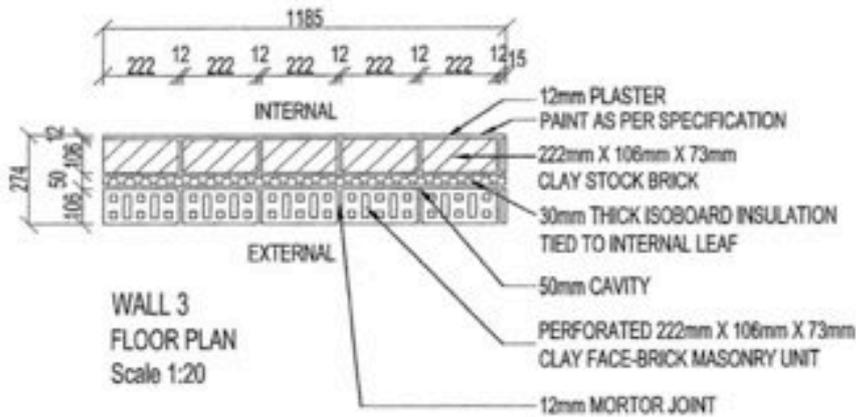
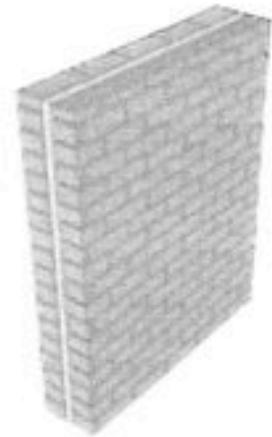
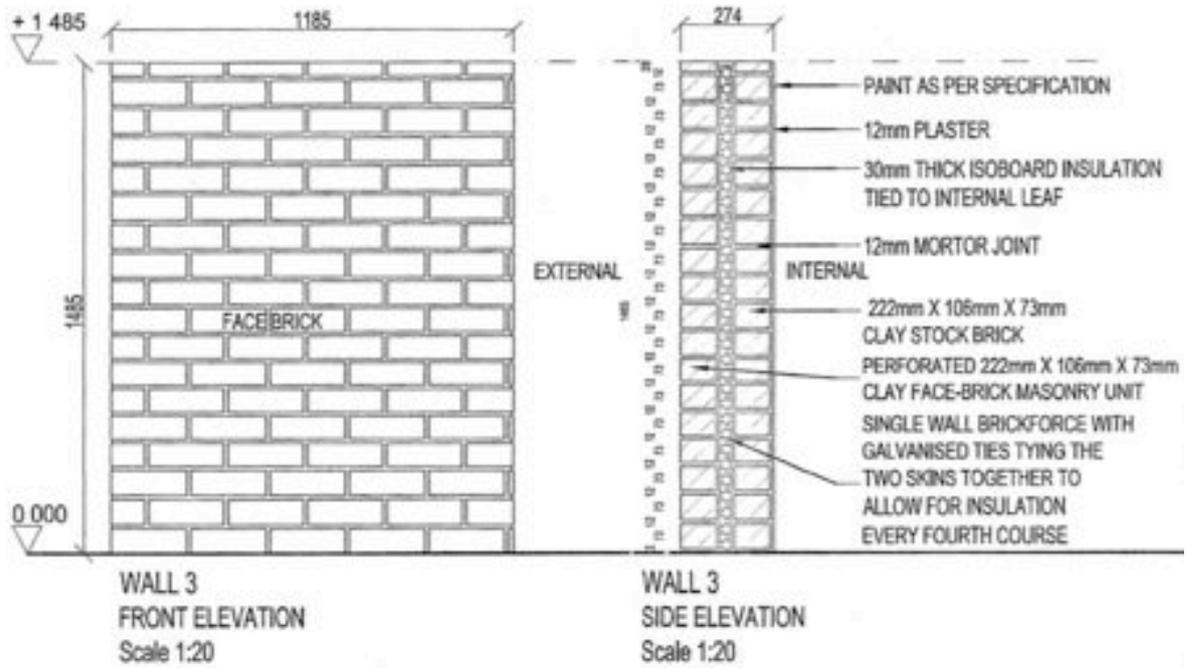
WALL 3

Measured thermal resistance for Wall 3 = 1.14 m²·W/K

- **WALL 3:** A double brick wall made from clay stock brick on the room side and perforated face brick masonry units on the climate side with 12 mm mortar joints, separated by 30 mm thick Isoboard insulation panels tied to the room side skin, with a resultant air cavity of 20 mm. The wall has 12 mm plaster on only the room side, painted white.

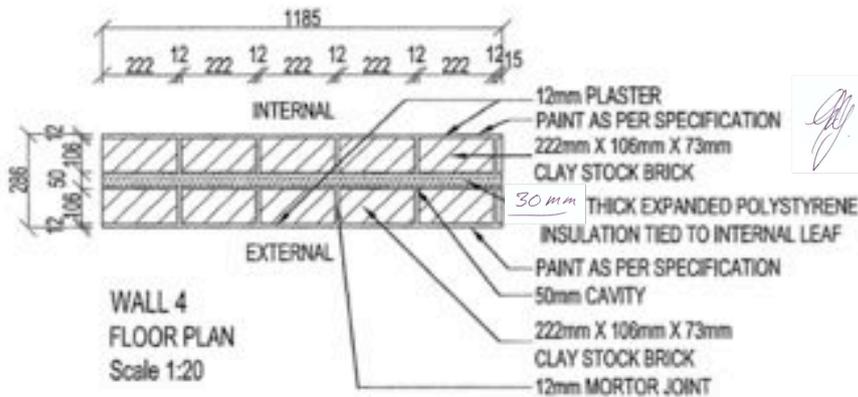
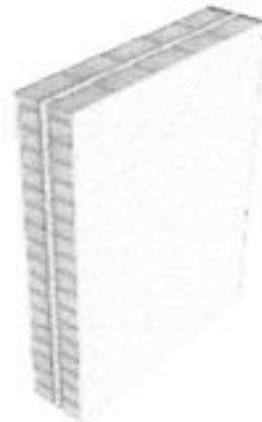
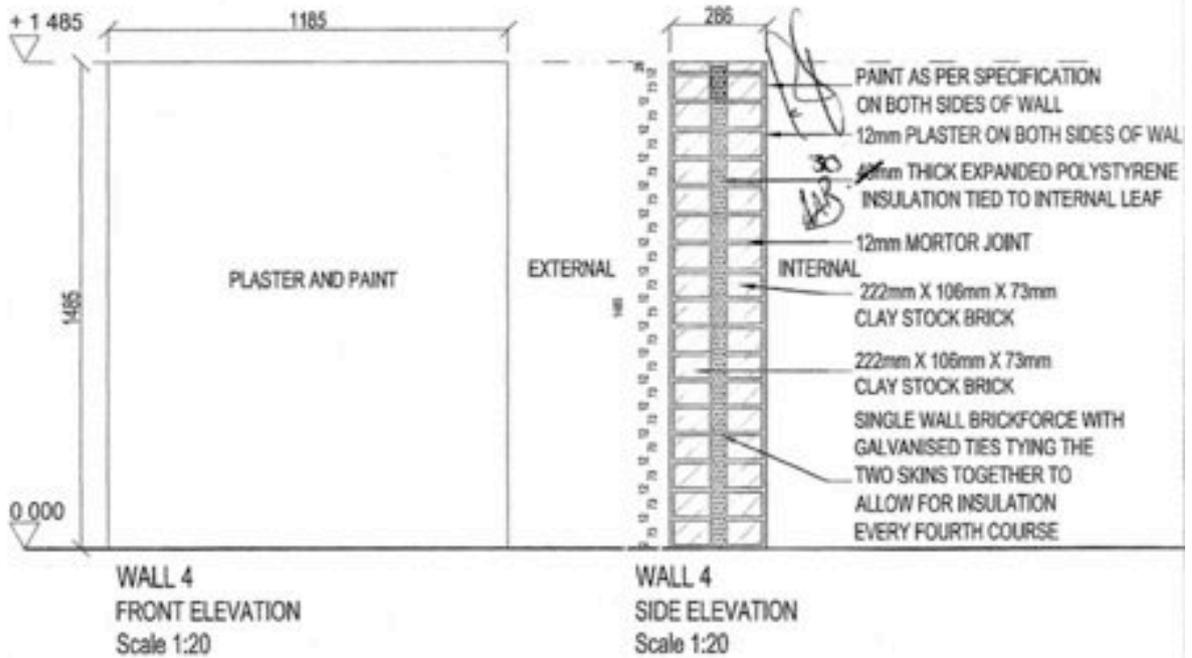
WALL 4

Measured thermal resistance for Wall 4 = $1.43 \text{ m}^2 \cdot \text{W/K}$

- **WALL 4:** A double brick wall made from clay stock brick on both the room side and the climate side and with 12 mm mortar joints, separated by a 30 mm Expanded Polystyrene insulation panels tied to the room side skin, with a resultant air cavity of 20 mm. The wall has 12 mm plaster on both surfaces, painted white.
